Analysis and Assessment of Agulu-Nnaka Erosion Impact on Human Lives and Infrastructure

OTTI, V. I and EKENTA, D. E

Civil Engineering Department, Nnamdi Azikiwe University, Awka

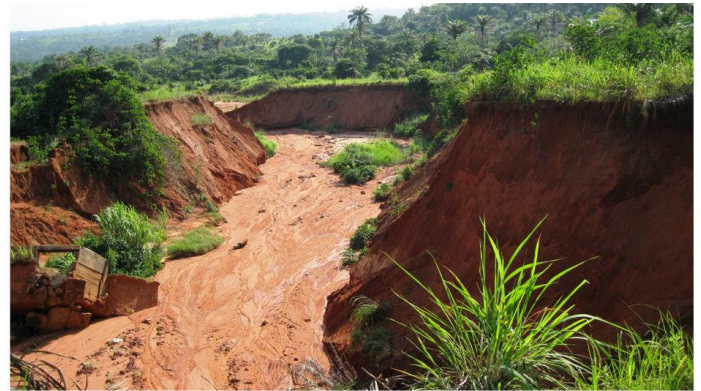
Figure (1) A section of gully in Agulu/Nanka both Aniocha/Orumba North LGAs

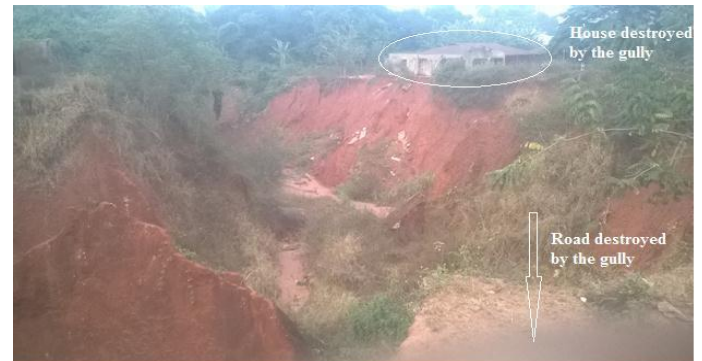
Figure (2) Gully at Agulu/Nanka showing some affected houses and tarred road.

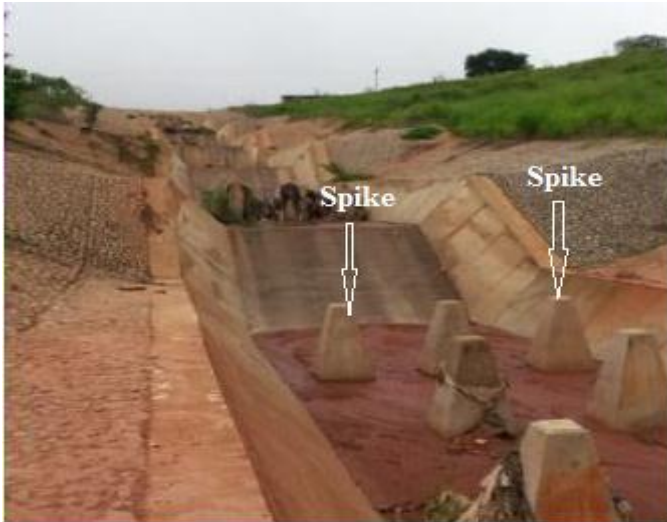
Figure (3) Step wise drop, chutes and spikes

construction of step-wise drop or rock chutes structure was to dissipate a large part of the energy of flow, and flat gabion mattress was laid on geotextile material. The construction company also used reno/gabion mattresses where necessary in protecting the base from scouring and re-vegetation of the gully site with local grass and trees within the distance of the gully and its fingers, see figure (3).

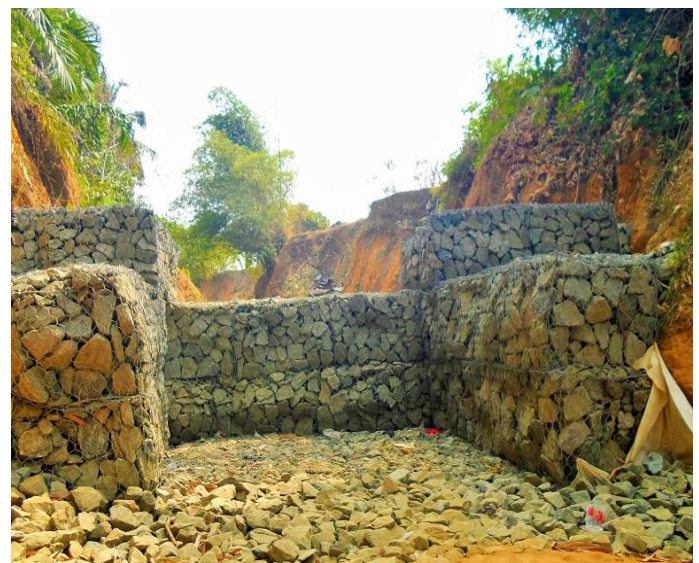
Figure (5) Gabions and Reno Mattresses used to protect infrastructure in vulnerable site

The design engineering structure resulted in the reduction of adverse impacts of the project. A sustainable engineering design for the intervention using gabion retaining walls and interlocked blocks over filtered materials at critical areas near the gully corridor was employed. This will help retain the existing structure thereby preventing possible demolition of the structure. Also geotextile was also employed in some area. The design for the catchment pit was realigned to avoid the project engulfing valuable building as well as other structures.

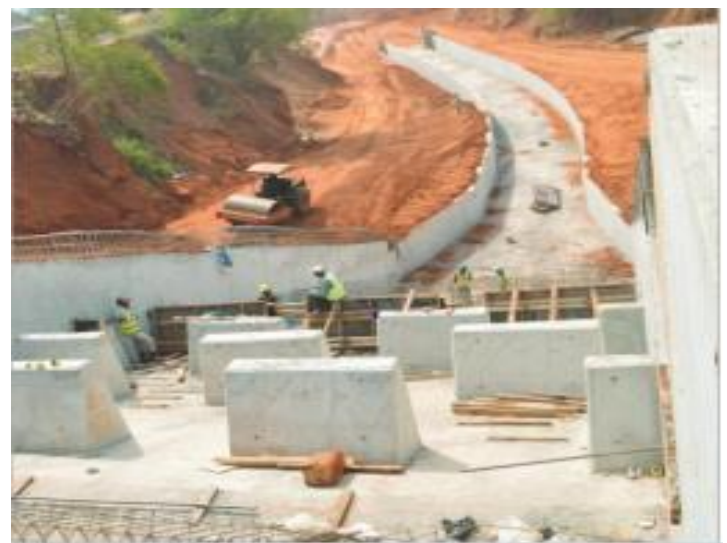
Figure (6) Spikes preventing undue acceleration of flow and dissipating energy.

were also filling and compacting to reclaim part of the gully head and its fingers gully construction of stepwise drop structure were made to dissipate a large part of the energy of flow.

Additional flat gabions mattresses were laid on the geotextile material and reno/gabion mattresses were used to protect the base from scouring.

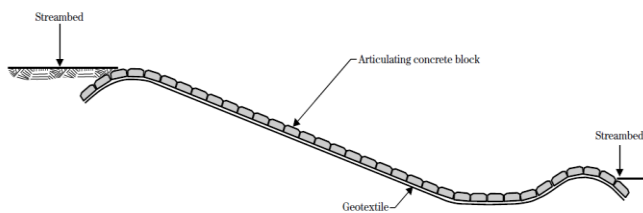
Figure (8) Articulated concrete block system in preventing erosion
