International Journal of Natural Science and Reviews (ISSN:2576-5086)

Disaster management strategy for avoiding the future losses by a slope failure at Nanhuan road, Fuxin area, Northeast China

Kaleem Ullah Jan Khan¹, Changming Wang^{1*}, Zhu Liang¹, Lixin Zhang²

¹College of Construction Engineering, Jilin University, Changchun 130021, P.R China.

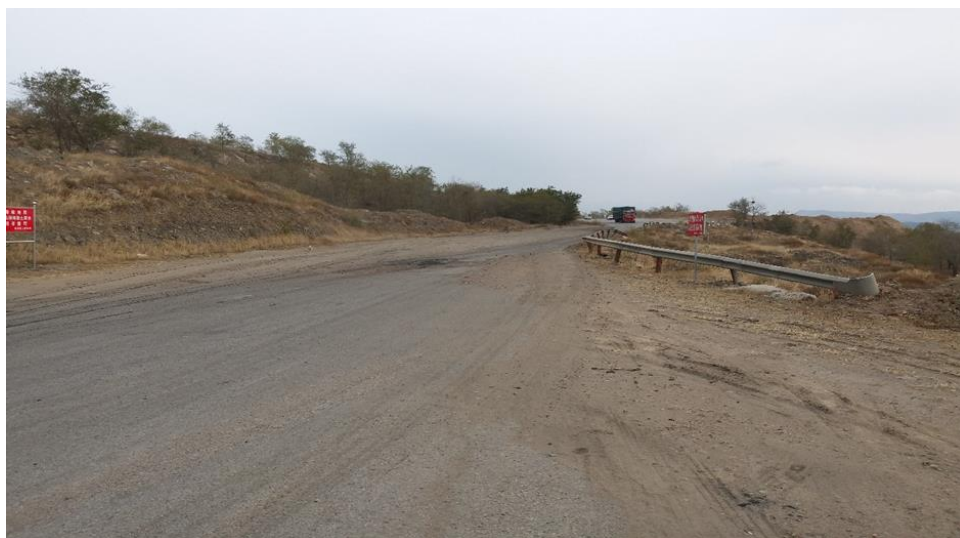
outcrop of the slope area is predominantly composed of silty clay overlain by a conglomeratic unit where the sandstone of cretaceous Sunjiawan formation is probably representing the bedrock. The top view of the failure zone can be seen in (Figure. 2).

Figure 2. Field view of Fuxin Slide Zone near top of the slope.

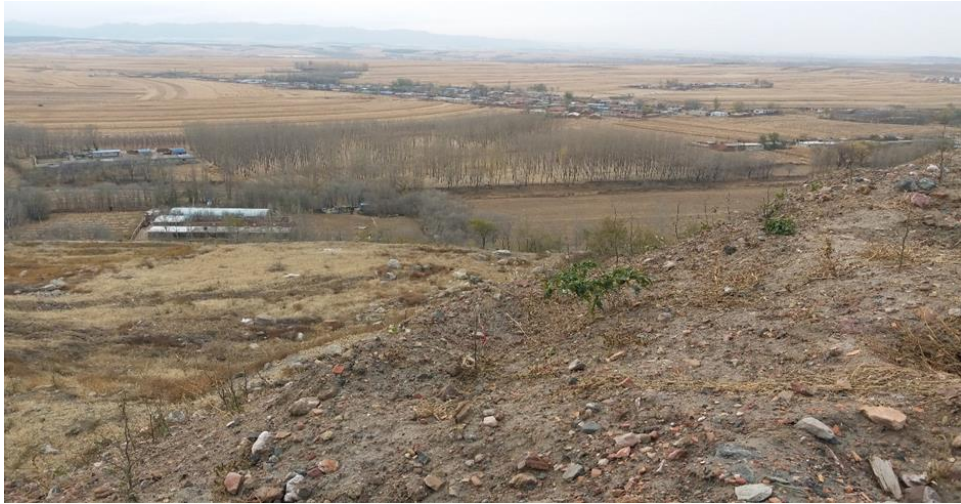
The exposed conglomeratic unit of the slope is presented in (Figure. 3 (a), (b)) which clearly

Figure 3 (a). Field view from right-top of Fuxin active slide failure zone.

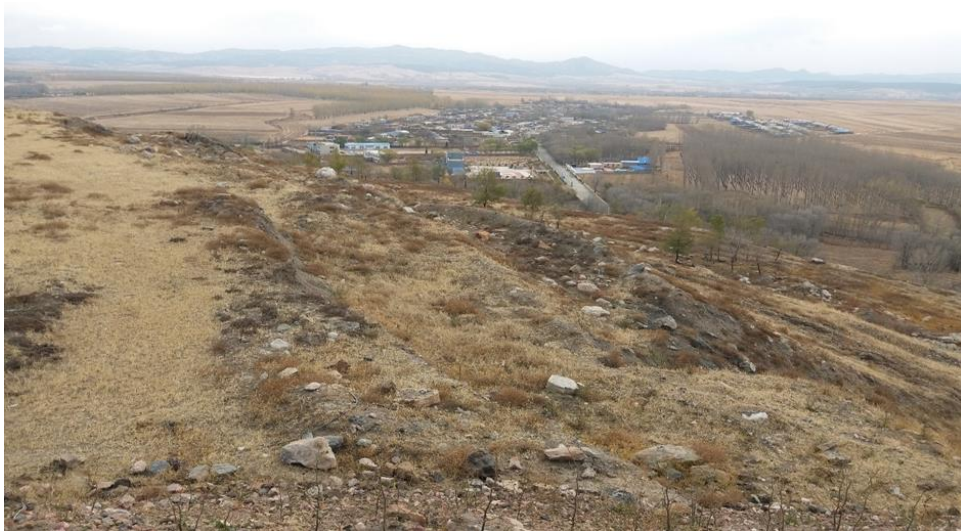
Figure 3 (b). Field view from left-top of Fuxin active slide failure zone.

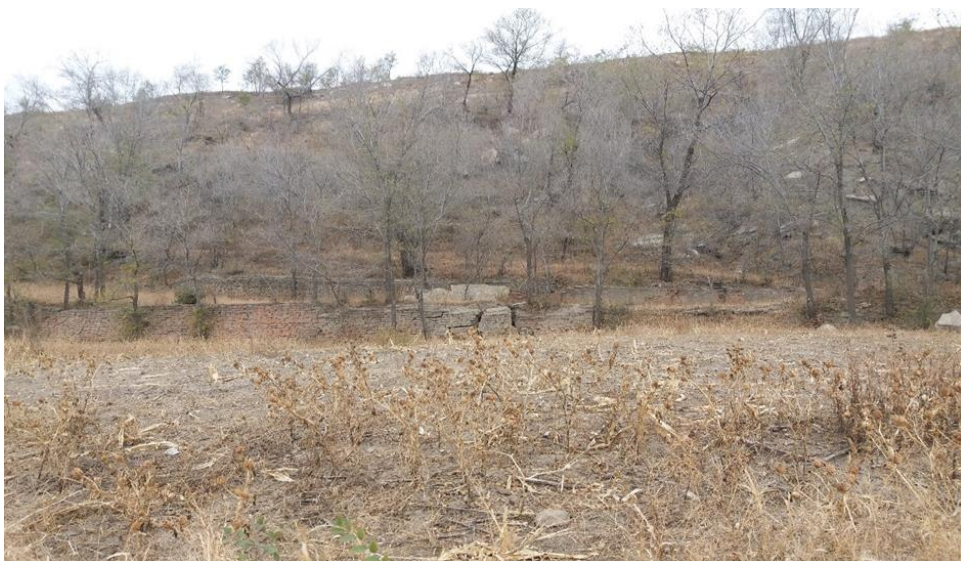
The occurrence of this landslide in Fuxin is observed at middle-low level (70 – 100 m) from top to downward direction causing damages in

the surroundings. The field view from bottom to top of the failed slope can be seen in (Figure. 4).

Figure 4. Field view from bottom to top of the failed slope (infrastructural damage can also be seen within the picture).

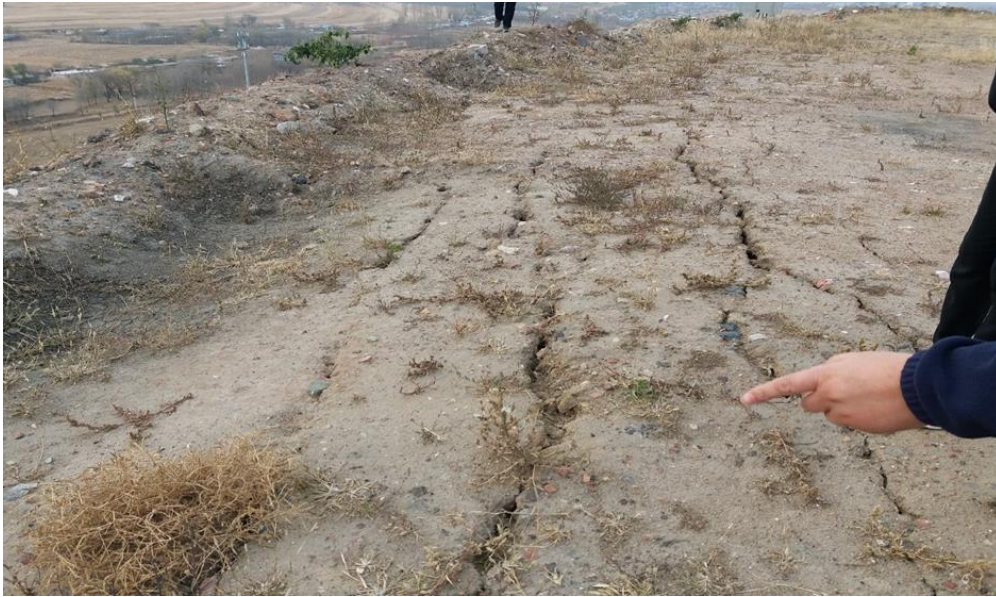
Fractures developed as the results of tensile and compressive strains generated due to overburden stresses from the surroundings can be observed at the top in conglomeratic outcrop of failed slope in dry and snow seasons (Figure. 5 (a), (b)).

Figure 5 (a). Nearby view of cracks near slope surface in dry season.

- There should be safe and planned disposal of materials for an artificial soil slope filling in the area.
- The slope should be modified wherever needed, especially in the zones with large fractures, to improve the stability.

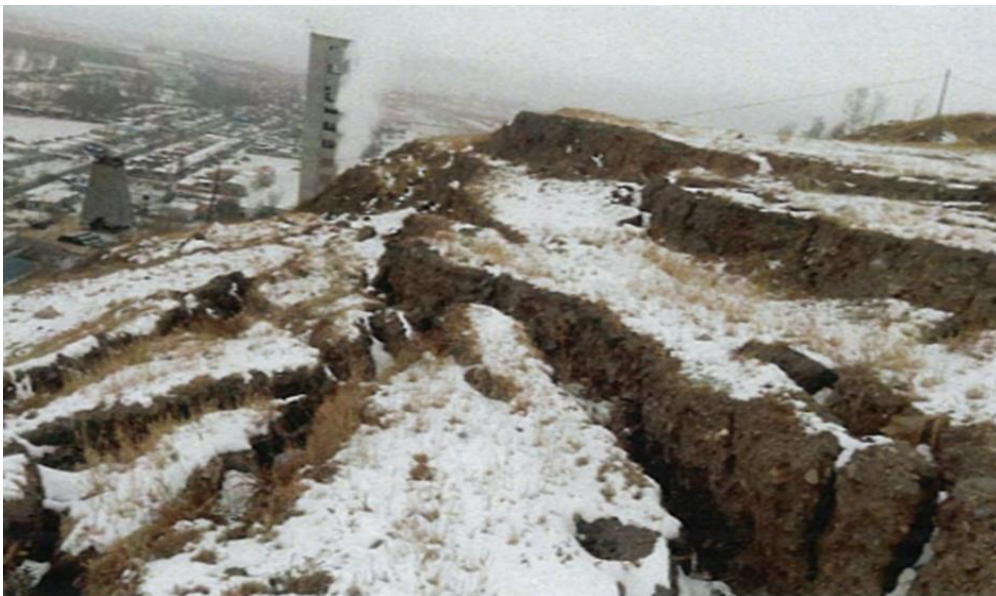
Figure 5 (b). Nearby view of downstream large cracks near slope surface in snow season.

increase the vulnerability of the failure zone as the snow water infiltrates within the large cracks of the sliding slope and as a result the shear strength of the slope is decreased, and also effect the vehicular traffic on the roads (which passes through the active slide zone) from early morning up to evening. The observed sliding mass, which is transported downstream have caused damage to agricultural fields and community lands. Furthermore, most of the work places and shops are operational at day time

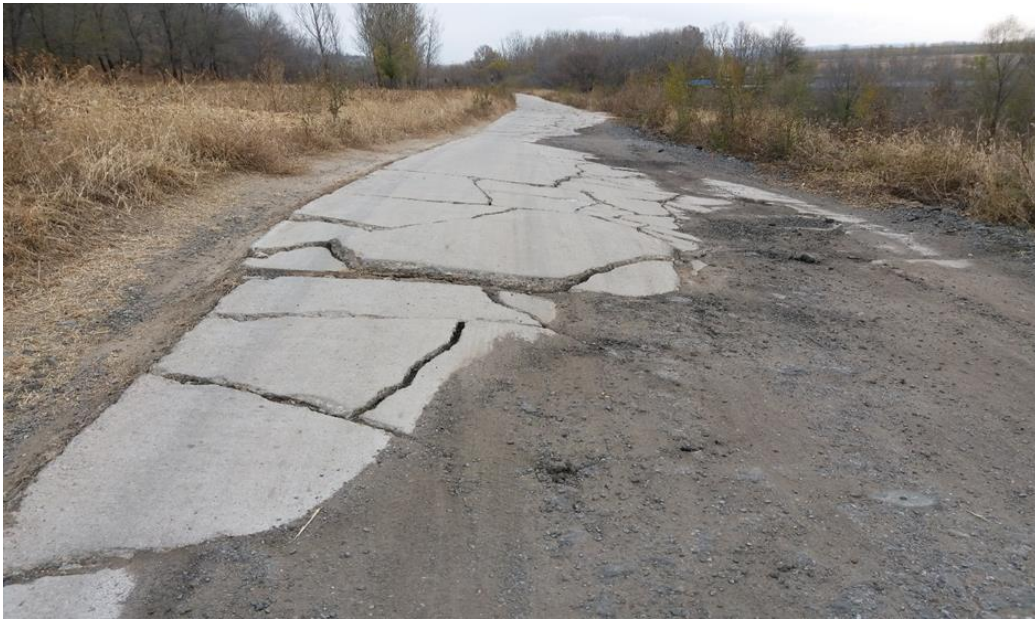
sizes of rock fragments including Sandstone, Silty clay and some related size large boulders). Large fractures nearby the roads at left and right bottom in the vicinity of the sliding zone have also been endangered which are observed during field investigation (Figure. 6 (a), (b)). The seasonal rainfall from May to October in the area further increase the risk of disaster.

Figure 6 (a). Field view of damaged road at right-bottom of the failed slope in dry season.

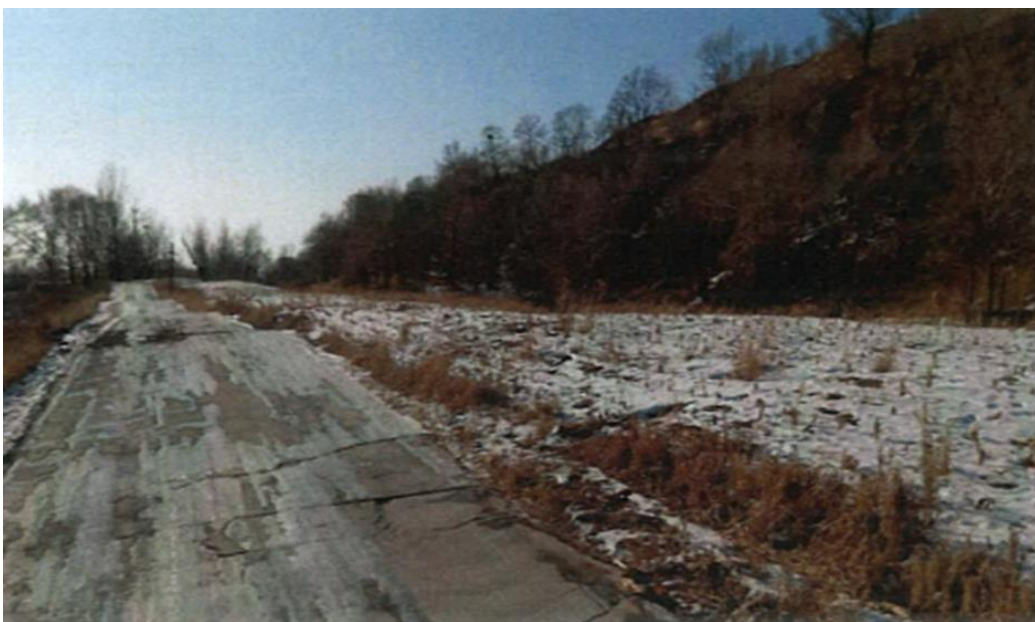
Figure 6 (b). Field view of damaged road at left-bottom of the failed slope in snow season.

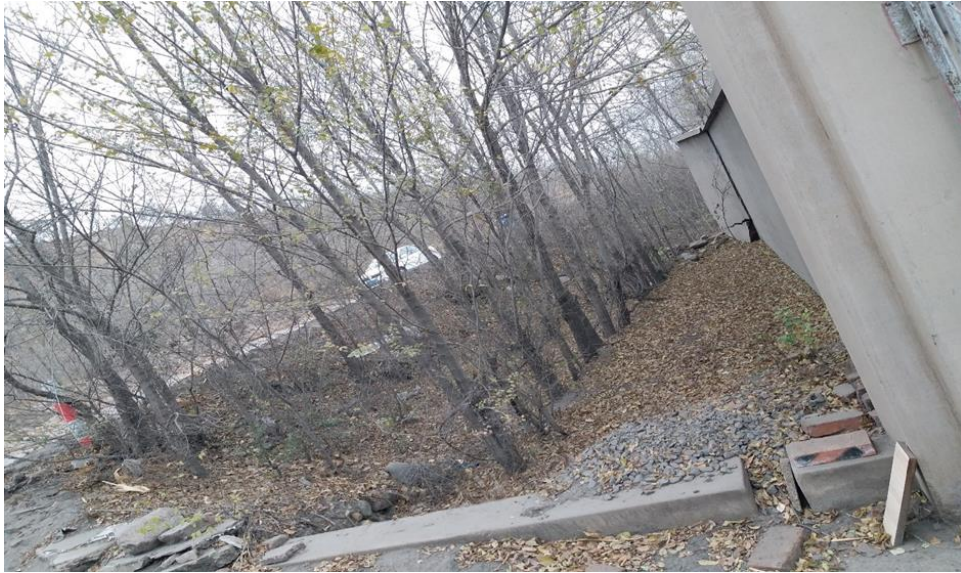
and amphibious population of workers and tradespeople is in and around, also some people work in nearby fields, which particularly increase the risk element in this area as many people are exposed to severe risk. This residential area has witnessed flowage in the form of hollowing and bulging in the surroundings: as large cracks developed within the ground and also infrastructural damages occurred (Figures 7, 8 and 9). Moreover, these severe damages have also developed fewer more sliding zones in the area.

Figure 7. Field view of damaged wall of irrigation office building nearby the failed slope.

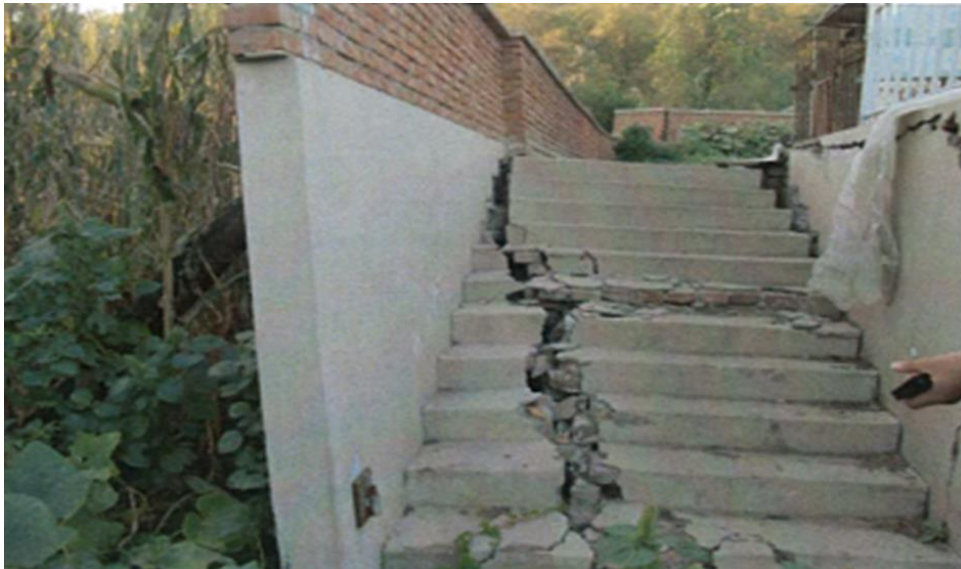
Figure 8. Field view of badly damaged stairs inside along the wall of irrigation office building nearby the failed slope.

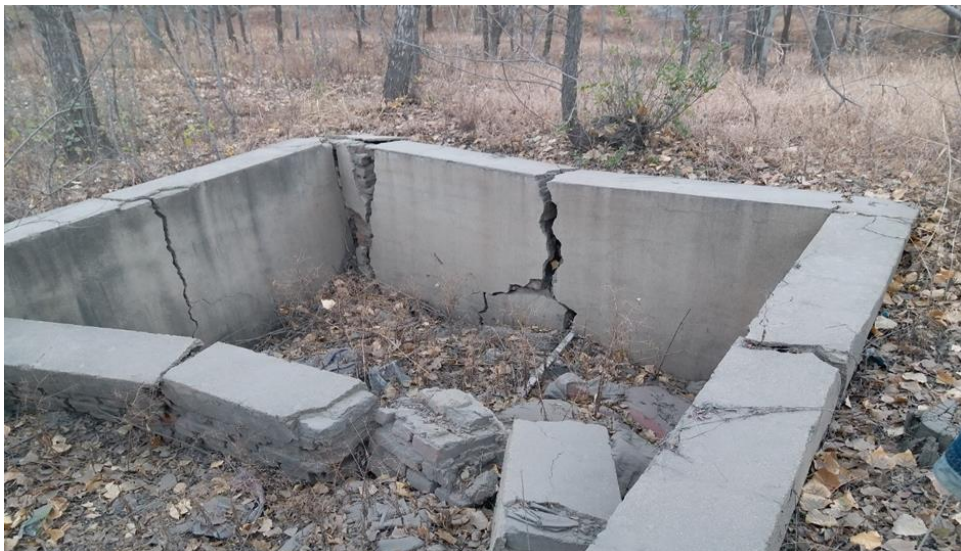
Figure 9. Field view of damaged water tank due to failure nearby the bottom of the slope.
