American Journal of Orthopedic Research and Reviews (ISSN:2637-4730)

Motion and its Effects on the Cement Mantle - A Biomechanical Analysis of Femoral Stem Displacement during Implant Cementation

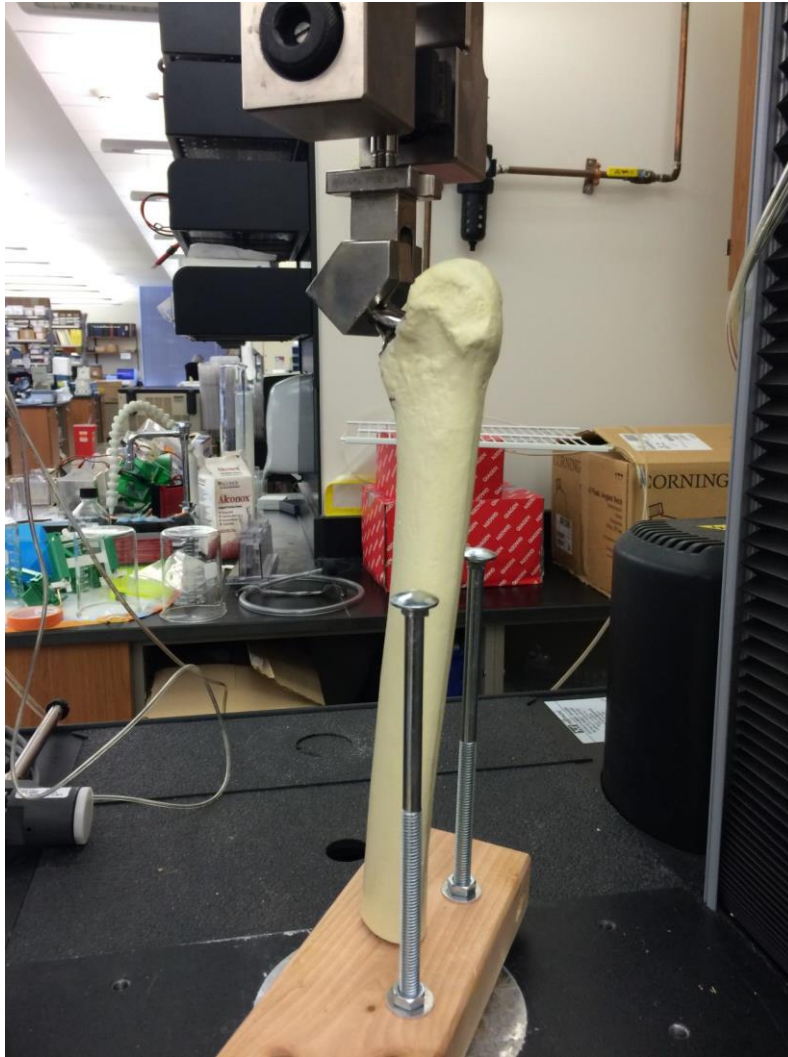
Figure 1: A custom rig designed to allow for pullout strength testing of cemented femoral stems from Sawbones models

Pullout strength testing was then performed on an Instron 5566 (Instron, Norwood, MA) and compared to a historical control of approximately 2000N.⁷ A custom rig was designed to allow for pullout strength testing. (Figure 1) Proximally, the stem was secured to the Instron using a clamp from a femoral extraction set (Stryker Howmedica Command, Stryker, Mahwah, NJ). Distally, the femur model was cut to the proximal portion of the metadiaphysis. A 5/8" x 6" galvanized lag screw was inserted into the model in a retrograde, intramedullary fashion. This secured the model to the base of the Instron through a predrilled section of standard 2x4" wood that allowed the lag screw to telescope through it. The base was secured to the Instron using 3/8" zinc-coated carriage bolts. The model was then tensioned utilizing a 10,000 N load cell at a rate of 0.05 mm/sec until failure was encountered.

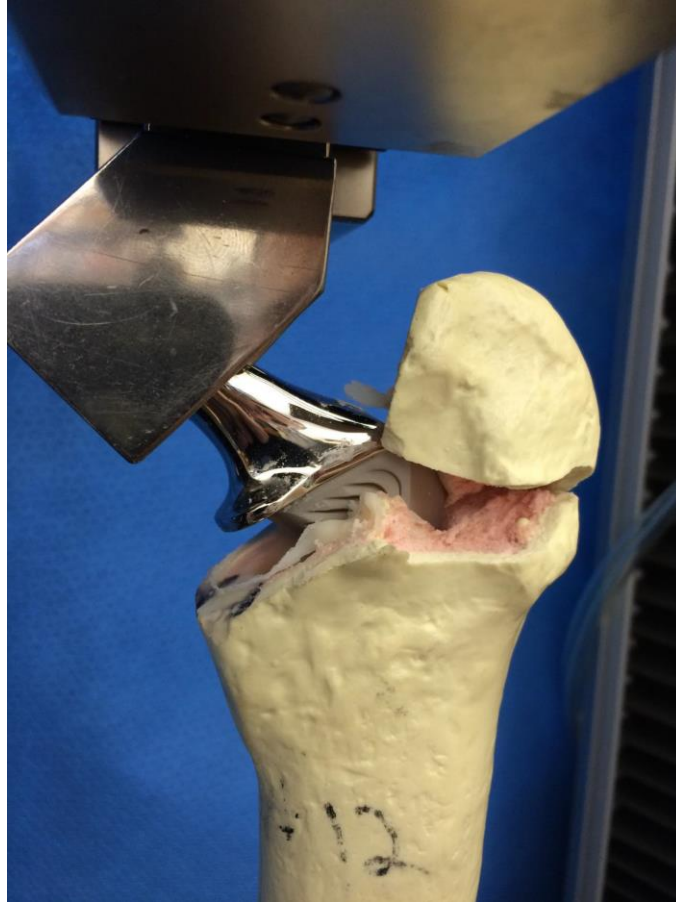
Figure 3: Experimental failure with stem pullout and greater trochanter fracture

Pullout strength testing of the control group demonstrated two of the three stems failed at a pullout strength greater than the published historical control. The third control stem was removed from the data evaluation due to testing error. (Figure 3) The remaining control stems, subjected to no rotational displacement showed an average pullout strength of 3735.79N. Both of these stems failed for periprosthetic fracture and not for stem displacement from within the cement mantle. (Figure 4)

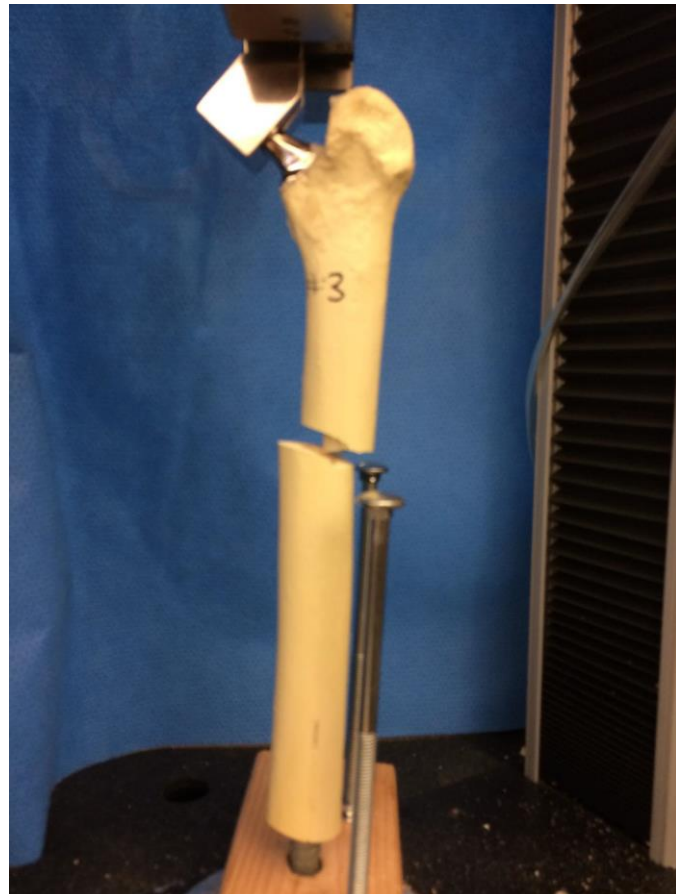
Figure 4: Experimental failure by periprosthetic fracture at the end of the cemented stem

The remaining experimental models ($n=18$) failed by periprosthetic fracture at the level of the stem tip-cement interface or distal to the cement mantle. Their average pullout strength prior to failure was 3215.06N, which was statistically significantly higher than the historical control group. The complete results are shown in Table 1.
