International Research Journal of Materials Sciences and Applications
(ISSN:2575-1034)

Optimizing the Surface Quality of Textile Composites for Bonded Repairs

With the accelerated use of woven composites in many industries like aerospace, marine, sports, construction, automobile and many more their repairs have become an inevitable part of it. The current problem with repairs is, even with precise machining there are bond failures due to inadequate surface quality. In this research, machining techniques like stepped and scarf repairs and abrasion techniques are used on the woven coupons to evaluate their influence on the surface characteristics. Preliminary evaluation of the surface characteristics is done using a surface profiler, to measure the topographical features like surface roughness and amplitude of the peaks and valleys. Further, the results obtained from the profiler are validated using microscopy and contact angle test to identify the trend between surface roughness and wettability. Finally, the results obtained from the various experiments helps us to identify an optimum surface quality needed prior to bonding in terms of surface roughness and contact angle. The resu

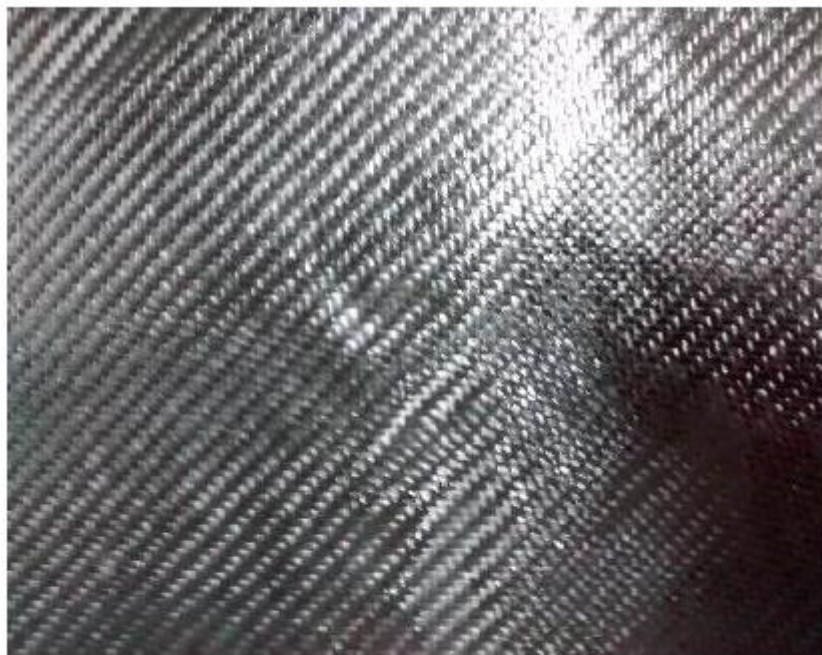
Woven glass fibre Prepreg of 600 gsm is used for this experiment as shown in Figure 2. The material consists of Tencate E722 mid temperature curing modified epoxy component.

Figure 2: 600 gsm woven glass fibre

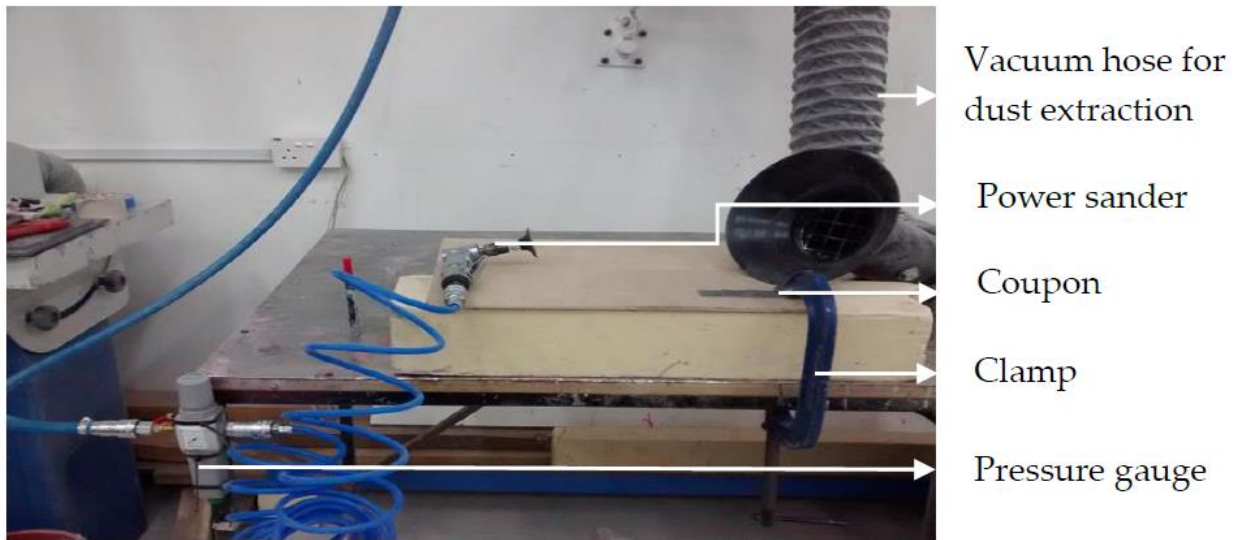
Figure 3: Experimental setup for coupon test

stepped and scarfed repairs. Figure 3, shows the test setup and Figure 4 shows the schematic of different tool paths for machining.

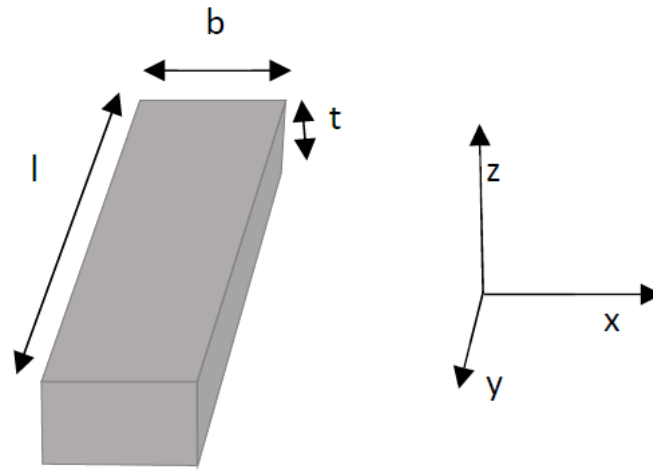
Figure 5: Schematic for coupon dimensions

After initial visual inspection of the coupons from machining, it is important to quantify the surface characteristics. This is done by using a Taylor Hobson surface profiler configured with Talyscan 150 software. During the experiment a 2D profile is chosen and the stylus runs over a certain sampling length i.e. the breadth of the coupon to record all the x-spacing and z-amplitude coordinates as shown in Figure 5. A total of 2401 points are obtained from the stylus and using the values of x and z coordinates all the surface profile parameters such as Ra, Rz, Rt, Rq are calculated which are discussed in depth in the results section.

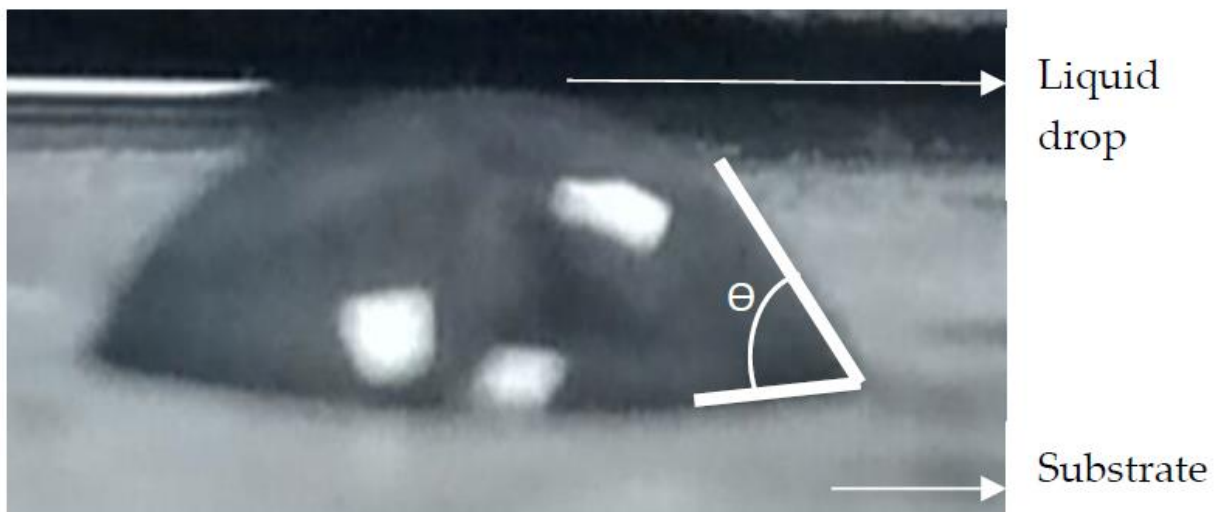
seconds. Distilled water at 20°C is used to avoid contamination and the coupons are dried properly to avoid moisture absorption. An angle of $\Theta = 41.20^\circ$ was obtained from the measurement using a camera. The images were post processed in MATLAB to measure the contact angle. The contact angle ranges from 0° to 180° where 0° indicates perfect wetting. Smaller the contact angle higher is the surface energy. This ensures good bonding characteristics. Figure 6, shows the liquid drop on a substrate to measure contact angle.

Figure 6: Contact angle measurement

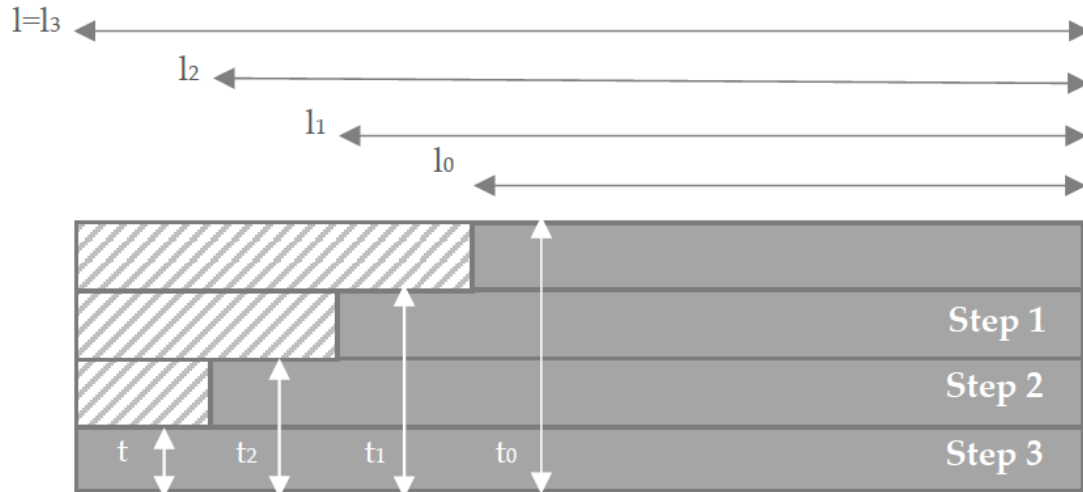
Figure 7: Schematic of type 1 coupon test

All the tests for type 1 (see Figure 7) were conducted at 3 bar pressure using a power sander running at 20,000 RPM attached with a P120 grit aluminium oxide sanding disc. The material removal was carried out as shown in the schematics where the hatched part denotes the removed material. The formulas listed below were used to find the material removal rate.

each coupon along the width of each step. The scans 1, 2 and 3 in Figure 10, shows readings for steps 1, 2 and 3 respectively as shown in Figure 7. In case of type 2, three scans on the taper were taken as shown in Figure 11,12,13 and for type 3, scans 1, 2, 3 and 4 in Figure 14 shows the readings on the respective steps 1, 3, 5 and 7 from Figure 9.

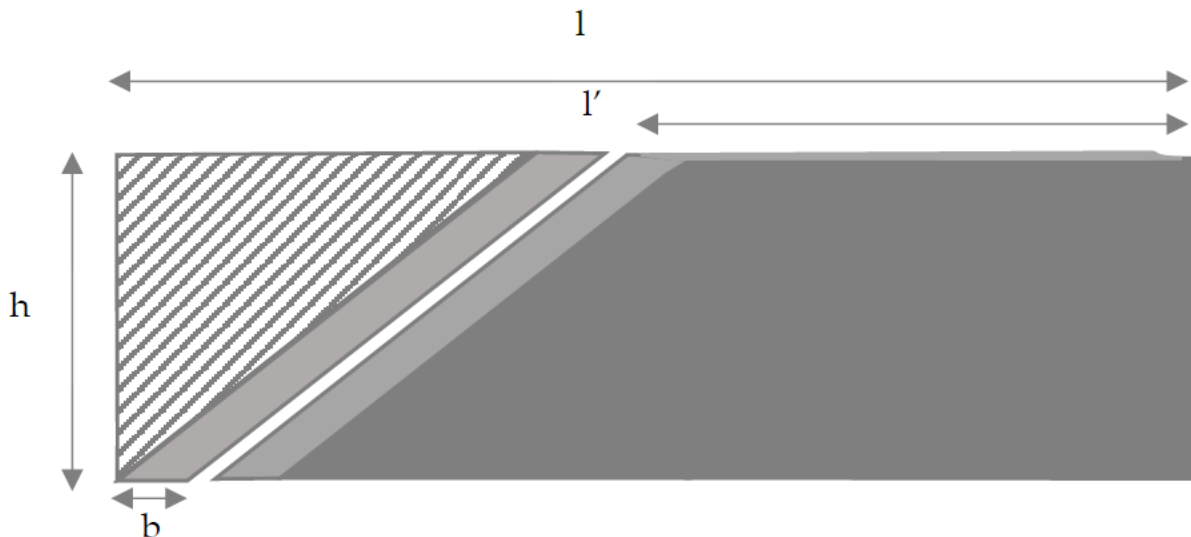
Figure 8: Schematic of Type 2 coupon test

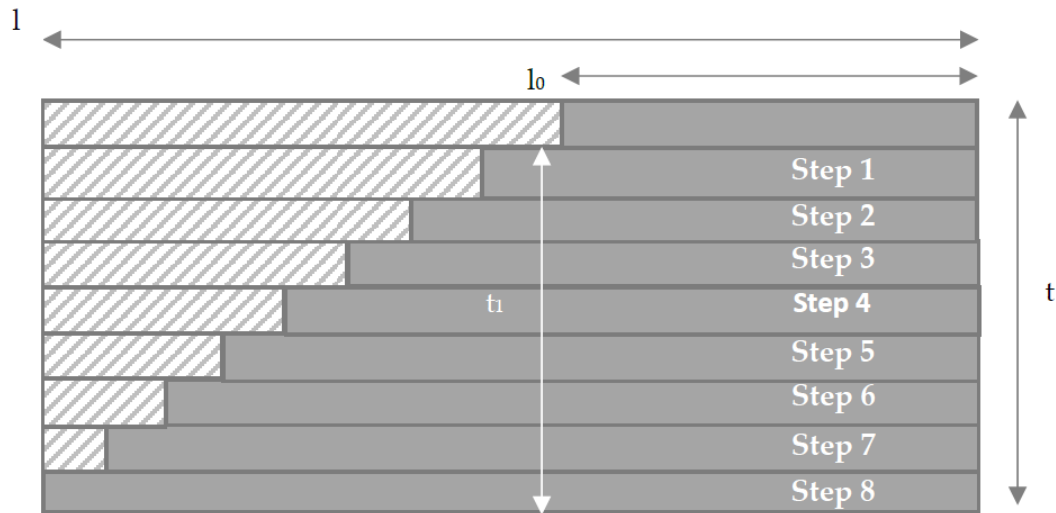
In type 3 test, a milling router was used with double cut milling bit. Layer by layer removal was adopted (see Figure 9) and precise

Figure 9: Schematic of type 3 coupon test

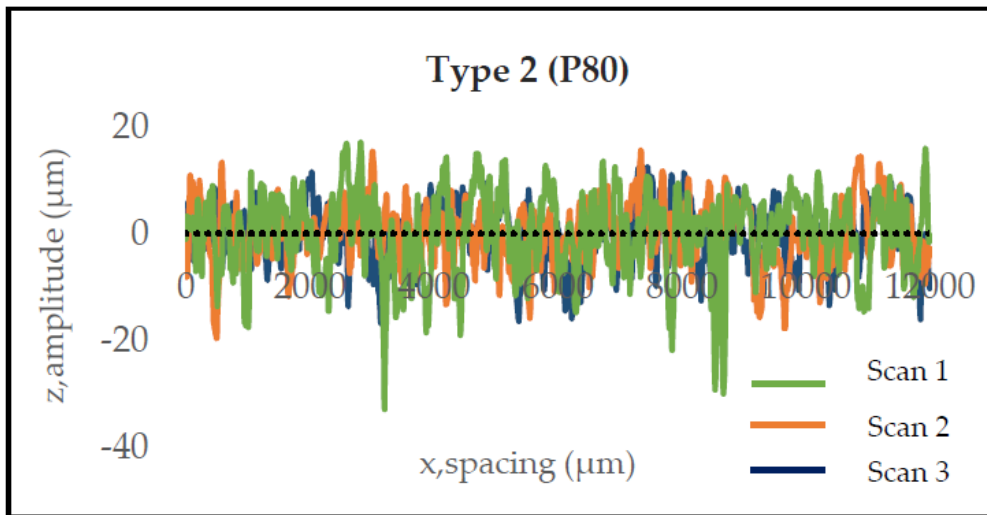
Figure 11: Surface profile graph for type 2 coupon test, abraded with P80 grit

In case of type 1, No abrasion technique was used after sanding which is evident from the fewer peaks and valleys on the surface as shown in Figure 10. However, in case of type 2 the profile of the surface abraded with P 80 grit sand paper has the highest peaks and valleys (see Figure 11) with P 400 marking the lowest ((see Figure 13). In type 2, coupon sanded with P220 grit (see Figure 12) a moderate surface roughness was obtained whereas, in type 3 due to the use of double cut milling bit, the peaks and valleys are sharp as shown in Figure 14, resulting in increased roughness values. The values obtained from all the points were averaged to calculate roughness parameters.

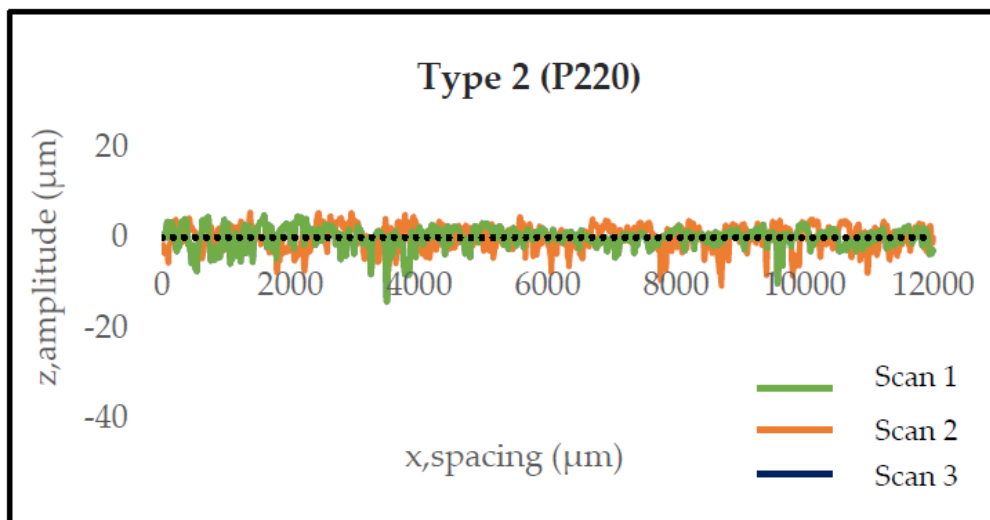
Figure 12: Surface profile graph for type 2 coupon test, abraded with P220 grit

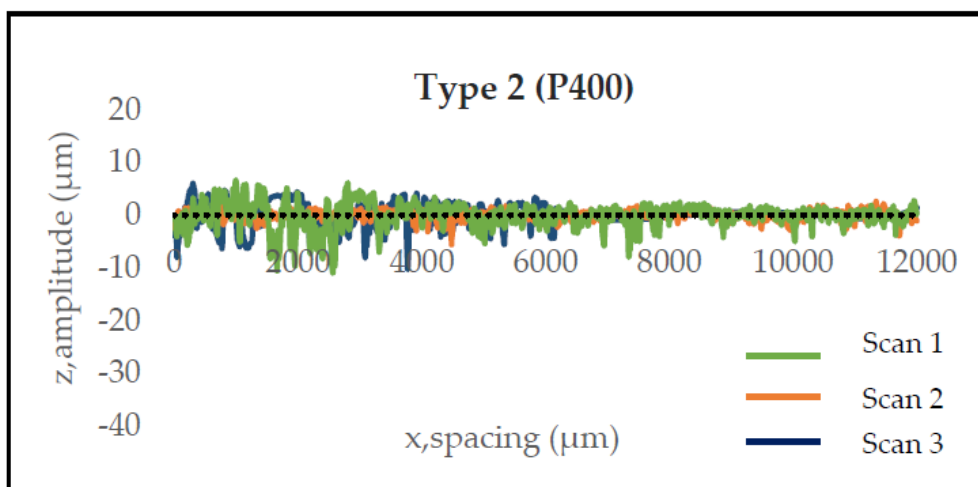
Figure 13: Surface profile graph for type 2 coupon test, abraded with P400 grit

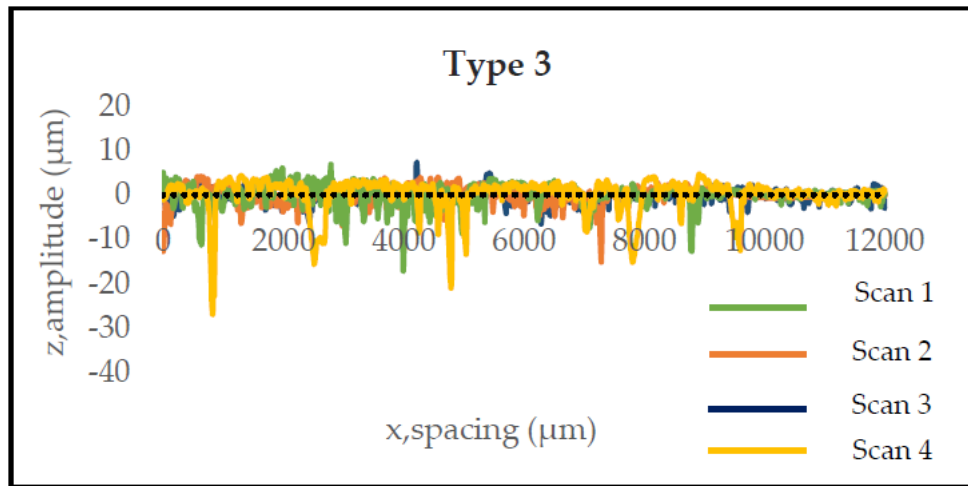
Figure 14: Surface profile graph for type 3 coupon test

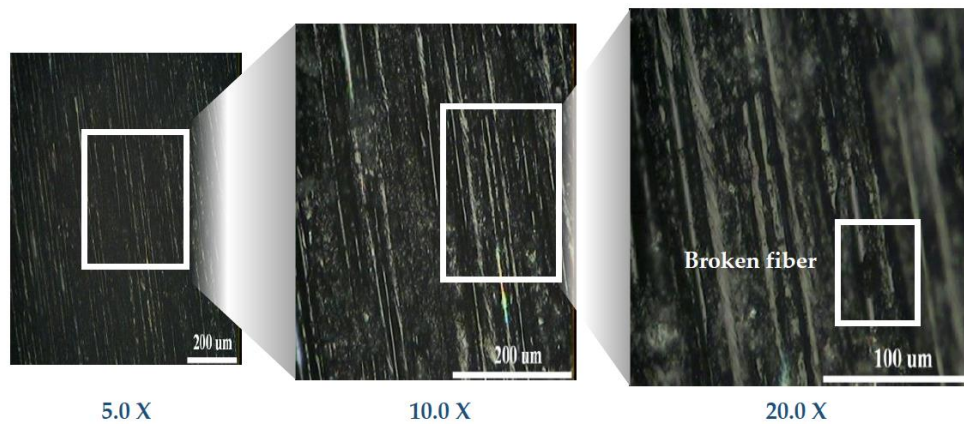
Figure 15: Microscopic inspection in type 1 test

image, a broken fibre can be seen in Figure 15, however the phenomenon is rare and it was observed only in one spot in the entire coupon. This was certainly different in case of Figure 16 where white abrasive marks are seen due to the abrasion with coarse grit sand paper which in turn results in a very high roughness value. Along with this the coarse particles can also be noticed on the surface of the fibre. A matrix dominated surface is obtained with P400 as shown in Figure 18 due to fine sanding whereas a fibre dominated surface is obtained due to the precise machining (see Figure 19). A fibre dominated surface can serve well for the incoming new patch and provide more reliable bonds.

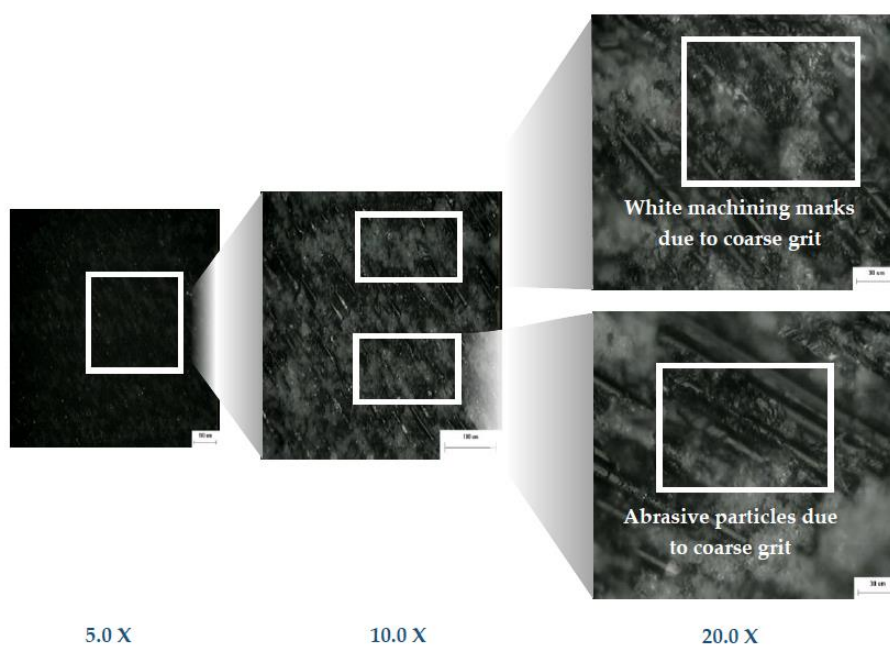
Figure 16: Microscopic inspection in type 2, P80 grit test

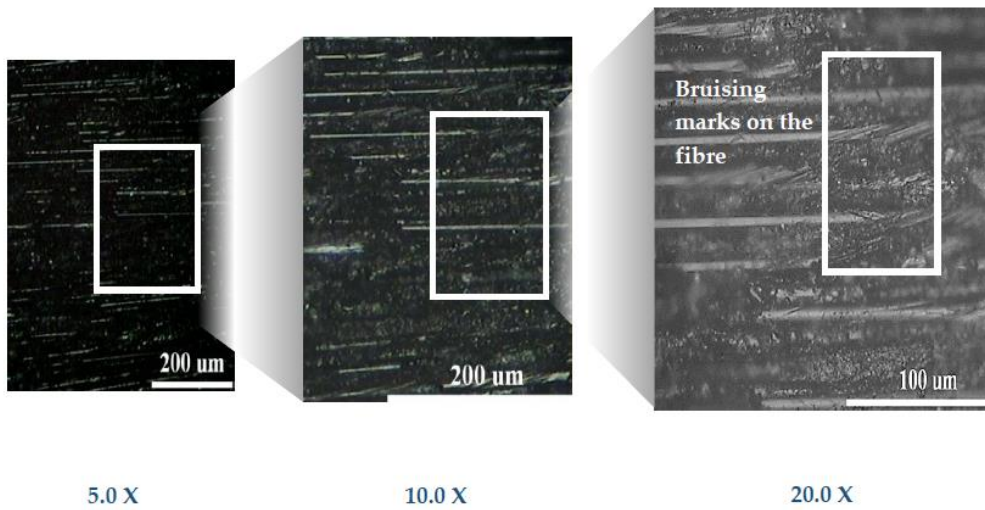
Figure 17: Microscopic inspection in type 2, P220 grit test

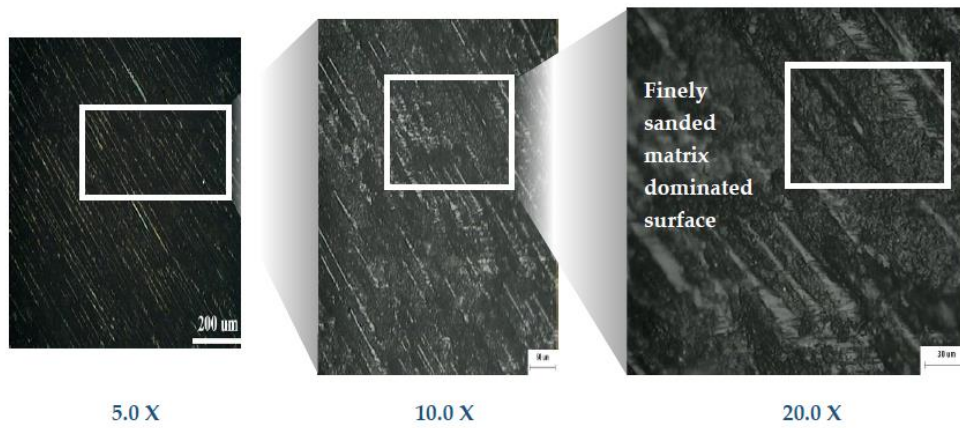
Figure 18: Microscopic inspection in type 2, P400 grit test

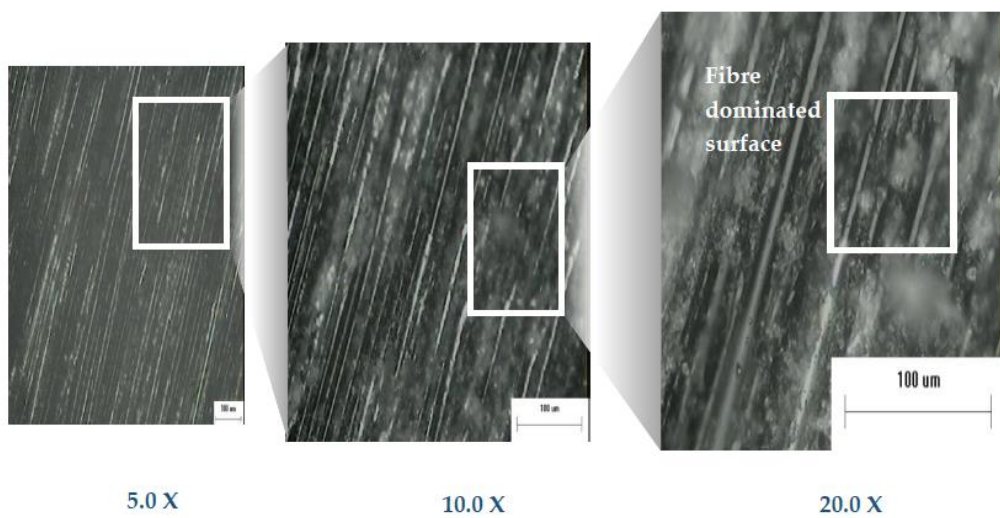
Figure 19: Microscopic inspection in type 3 test

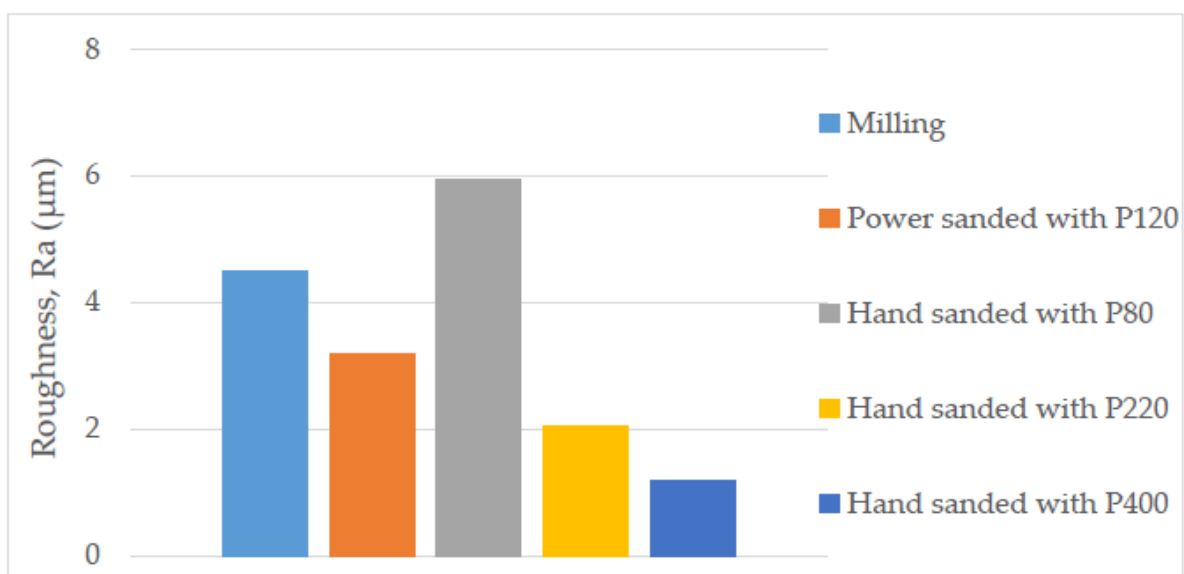
Figure 20: Roughness (Ra) for all the coupon tests

Figures 20 and 21, compares the values of Ra and Rz for all the coupon tests respectively. From the histogram of Ra values, it can be clearly seen that the sample hand sanded with P80 has the maximum surface roughness and that of P400 has the minimum. In case of P220 the initial operation was done using a power sander (P120) and further hand sanded with P220 this reduces the value of Ra from 3.2µm to 2.05µm as shown in Figure 20. For milling the roughness is acceptable considering to the use of tool unlike sanding disc and a uniform surface was obtained predicting good bonding characteristics.

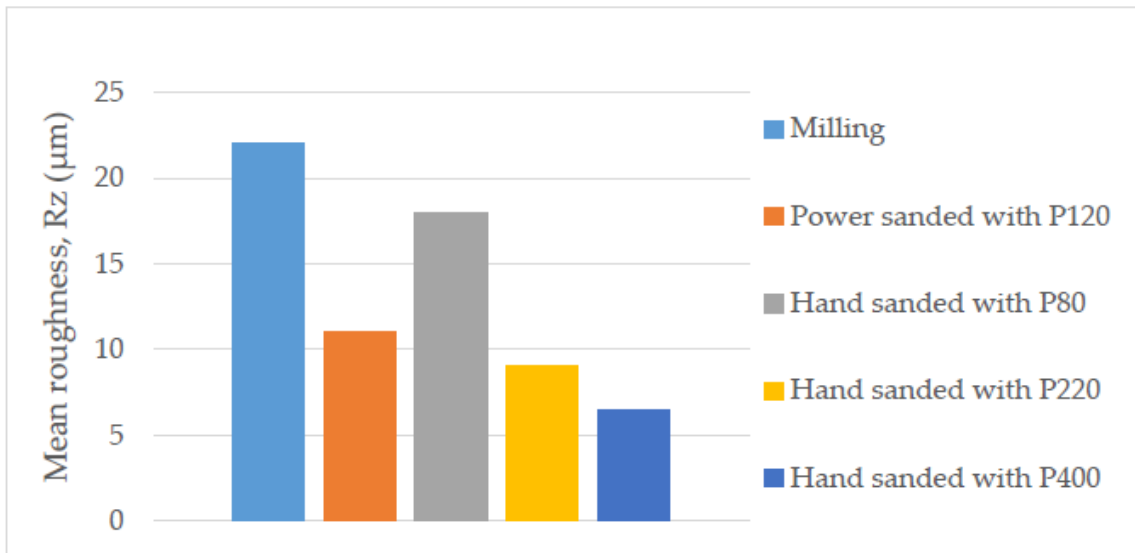
Figure 21: Arithmetic mean roughness (Rz) for all the coupon tests

Looking at the corresponding Rz in Figure 21, it is seen that milling has the highest number of peaks and valleys exceeding P80 which can be attributed to its tool geometry and sharp edges of the double cut tool. For P220 the Rz values are notably smaller with P400 being the least. In addition to Ra and Rz the contact angle is one essential factor to be considered when evaluating surface quality. Low contact angle and high surface energy activates the adherend surface for the incoming repair patch to bond effectively with the parent material. In Figure 22, it can be clearly seen how sanding improves the contact angle compared to milling and P120 grit.

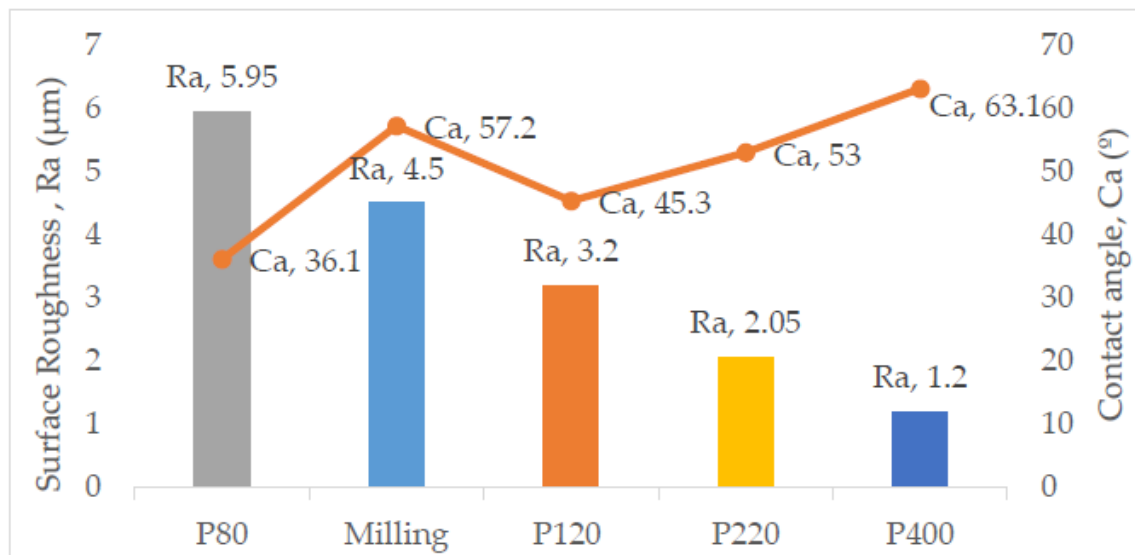
Figure 22: Correlation of surface roughness with contact angle
