International Journal of Natural Science and Reviews (ISSN:2576-5086)

Disaster management strategy for avoiding the future losses by a slope failure at Nanhuan road, Fuxin area, Northeast China

Kaleem Ullah Jan Khan¹, Changming Wang^{1*}, Zhu Liang¹, Lixin Zhang²

¹College of Construction Engineering, Jilin University, Changchun 130021, P.R China.

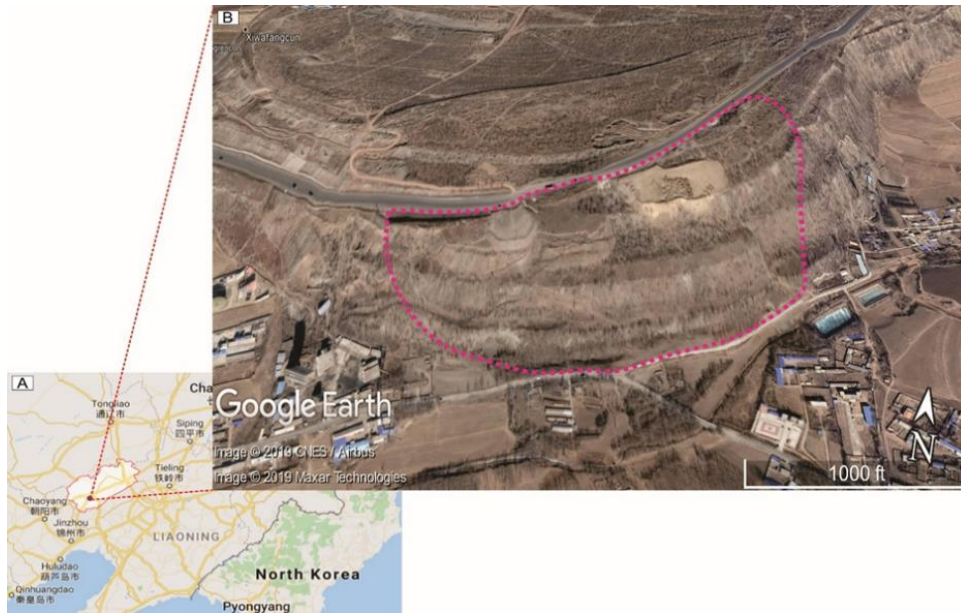
Figure 1. Location of the area under study (the area encircled is representing prominent failure).

The area under study is located at Nanhuan road, Fuxin city, situated to the west of Liaoning province, Northeast China (Figure. 1). The west of the area is adjacent to Chifeng, Inner Mongolia and is mainly controlled by the air-flow from Xipoliang to Inner Mongolia. The maximum and uniform wind speed is 7 m/s and $1 - 3\text{ m/s}$ respectively. Xihe river in the west and Guanshan river is located southward of the failure zone.

The landform of the site under study (Figure. 1) in Fuxin is mainly hilly area which is piled up manually approximately 30 to 80 m with conglomerates and other related size boulders with underlain silty clay in an excavated open-pit mine for approximately 50 years ago. The
